Pump Caisson Repair

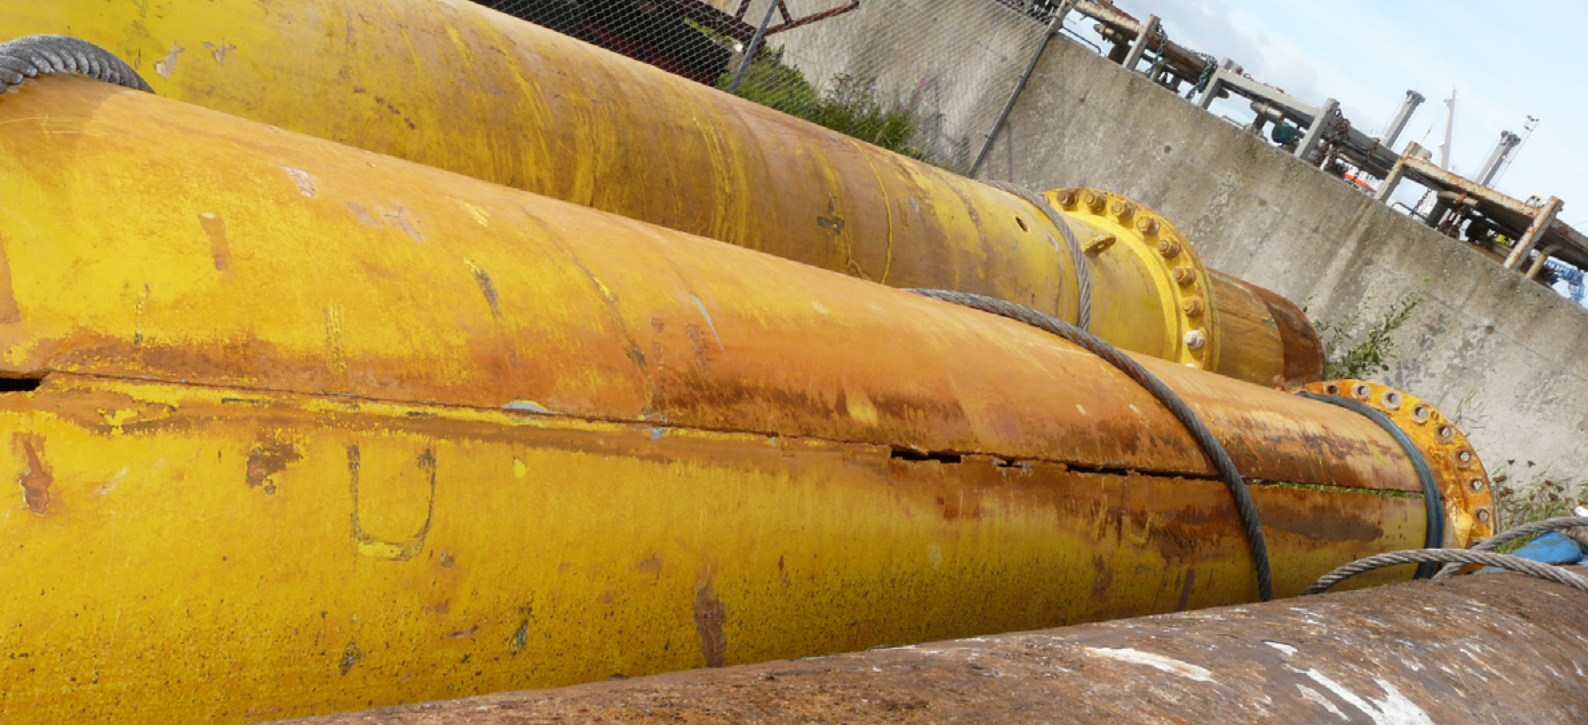
Seawater caissons are used extensively offshore for applications such as fire pump seawater intake and cooling water discharge. Due to high erosion and galvanic phenomena linked to the seawater pump service, regular repair and change out of the caissons are required.

For full change out of caissons LICEngineering A/S made the designs in sections utilising wellknown threaded / stabbed connectors from the drilling industry. Oilstates outside flush connectors were applied to obtain that the new caissons could be installed into the existing guide support system once the old caisson was removed and without diver intervention.

The new designs included at some locations special polymer / glass fibre reinforced lining. Design of the caisson tip with a special camera support system mounted was undertaken, thereby ensuring that correct stabbing was achieved at the lowest subsea support.

Tools were designed to allow safe removal of partly corroded existing caisson pipe first, which was then taken out in sections.
